SILICONE ROOFING SYSTEMS

## When Interior Climate Matters Most:

# Working Quickly and Efficiently

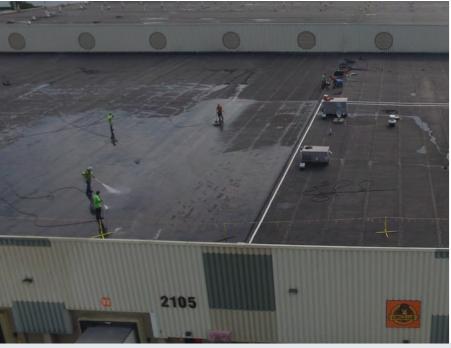
The entire roof had to be powerwashed to clean off a black substance present on many EPDM roofs.

- Perform infrared scan to locate and replace wet insulation
- Apply P-120 EPDM Rinseable Cleaner
- Powerwash roof surface to remove cleaner
- Repair any seam or flashing failures

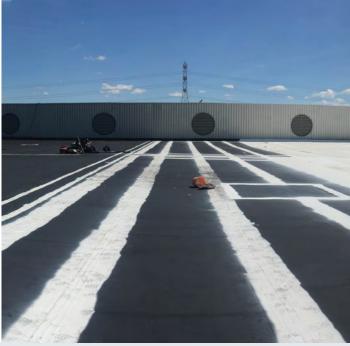
A halfway-coated black roof illustrates the benefits of a reflective roof, as you can see the difference in brightness on the wall.

- Prep seams with FT 500 Butyl Fleece Tape and PF 212
  Polyester Fabric for increased strength
- Apply 30 mils of HS 3201 Silicone Roof Coating to field of roof in a single coat
