PROTECTING THE HOOSIER GYM PRESERVING A STATE TREASURE

Knightstown, Indiana

Project Profile

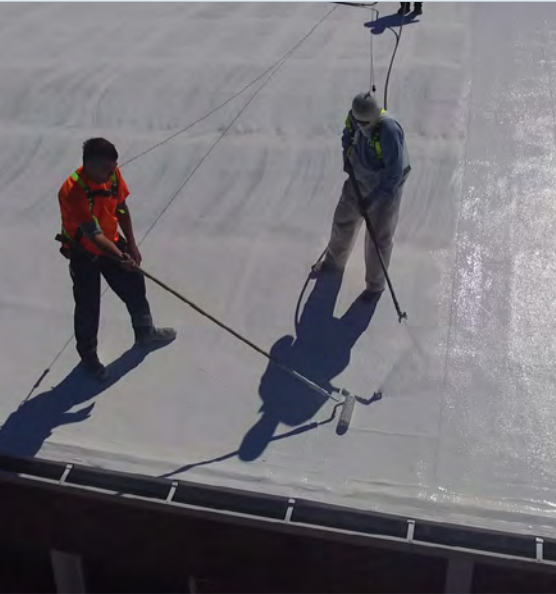
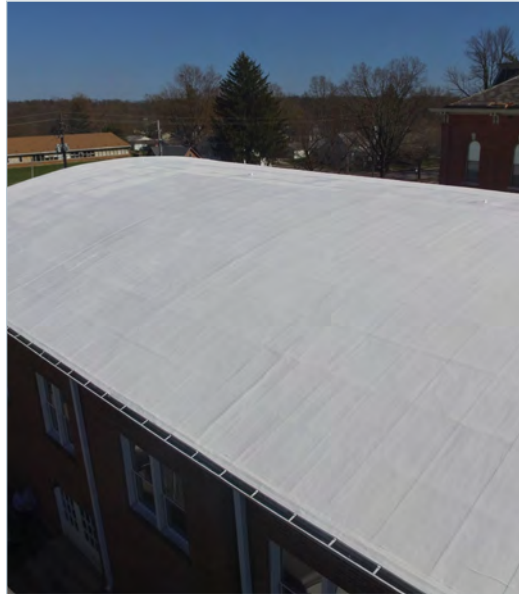
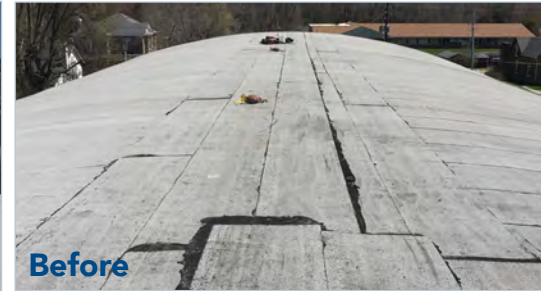
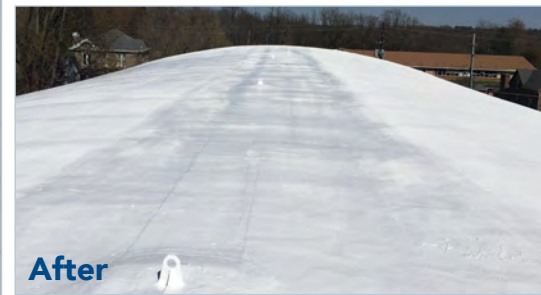
The roof was coated using a combination of spraying and rolling the coating to ensure all seams and crevices were completely filled and sealed. This also allowed the contractor to ensure the coating was applied at the correct thickness.

- Installed anchors at the peak of the roof to tie off workers and ensure safety while working.
- Power washed the Modified Bitumen roof to remove all dirt and grease stains.
- Applied an extra layer of silicone coating to any damaged seams to ensure no leaks would appear.
- Coated the field of the roof with two coats of 100% silicone coating.
- Coated a curb on the west side of the building to completely encapsulate the roof.
