HOW A NATURAL DISASTER UNITED A REGION

Henryville Schools, Indiana

Project Profile

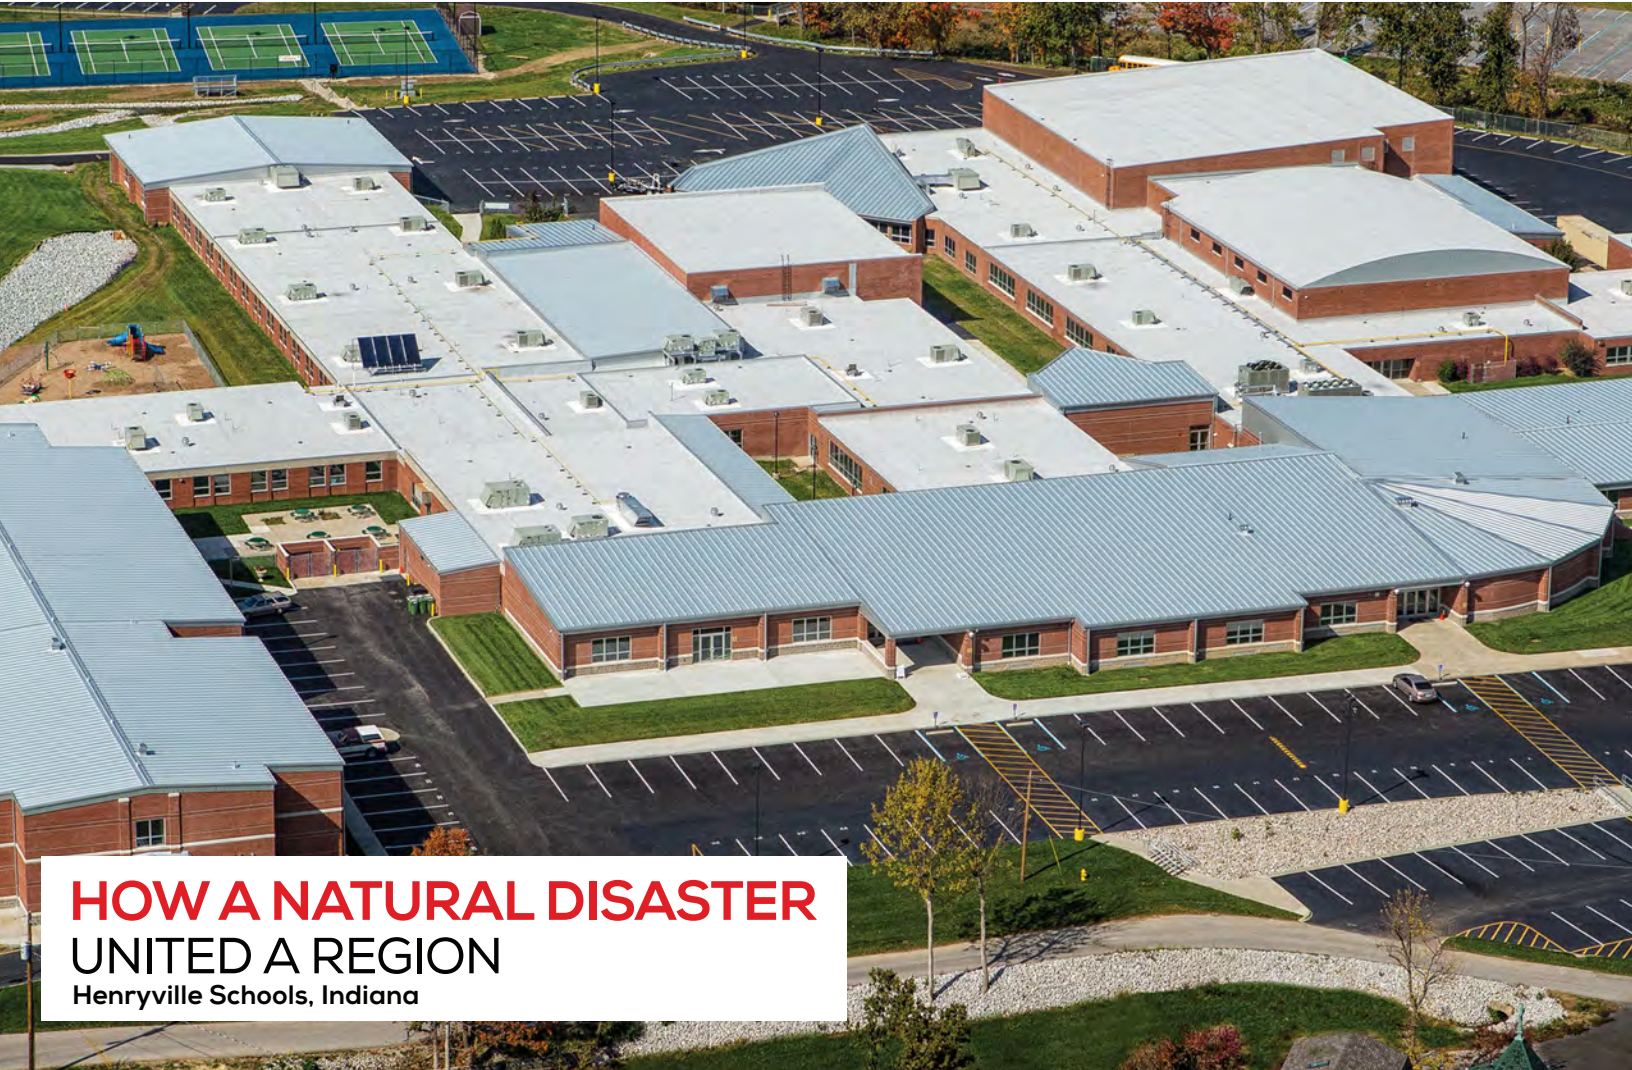
Shortly after the students' dismissal, a tornado of 170 miles per hour nearly demolished the entire school complex. There was roof damage, structural steel damage, drywall damage, brick damage, and doors and windows blown out. Since the two distinct buildings were a combination of various roofing materials of varying ages, all roofing needed to be removed and replaced.

The damage was so extensive that multiple teams of construction crews needed to work simultaneously. But, no work could be started on the interior of the buildings until the roof had been totally removed and replaced.

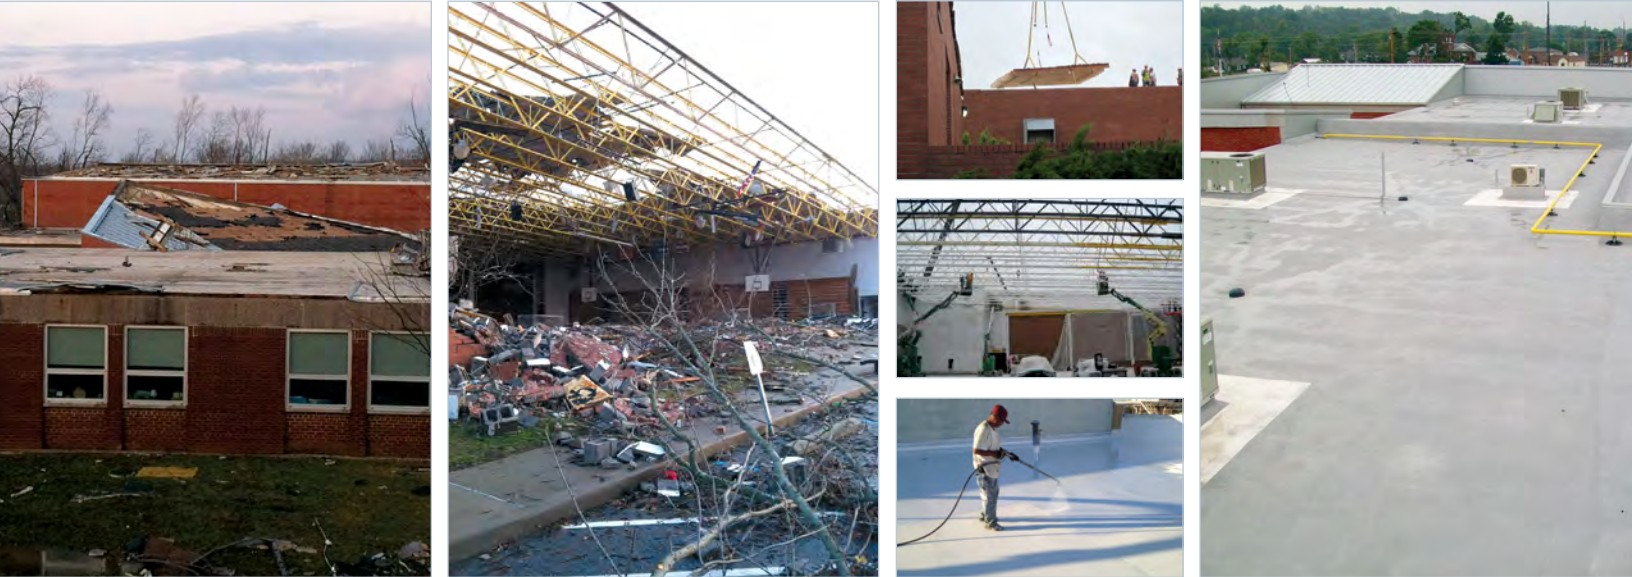
Tornado damage to the Henryville school buildings was extensive, with entire portions of the buildings demolished. The tedious process of removing damaged sections and rebuilding occurred around the clock. Within 6 months the entire structure had been rebuilt for the start of the next school year. The new roofing system takes advantage of cutting edge technology and is now sustainable and energy efficient.

- Removal of the remaining roof materials.
- Removal of the entire poured gypsum roof deck.
- Installation of new 22 gauge metal roof deck.
- Installation of new insulation board.
- Installation of the new Progressive Materials SPF roof system consisting of 1.5 inches of the SF 4228 spray foam and 25 mils of the LS 2200 Series silicone coating.
